DRIP...DRIP...DRIP

M1000 HET Semitrailer...

Ramps Get Dry Lube

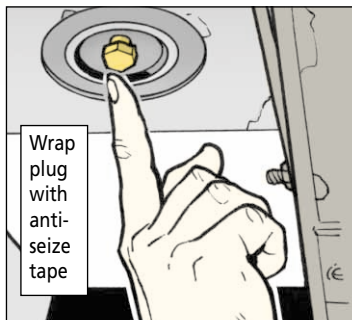
Leaks around the plastic plug, NSN 4730-01-086-1620, under your water trailer probably means it was overtightened when it was first installed.

Overtightening strips threads, causing leaks. It also makes the plug hard to remove.

So head off leaks and removal problems by wrapping every new plug's threads with anti-seize tape, NSN 8030-00-889-3535, and by lightly snugging it in place. That way, the plug can be used several times.

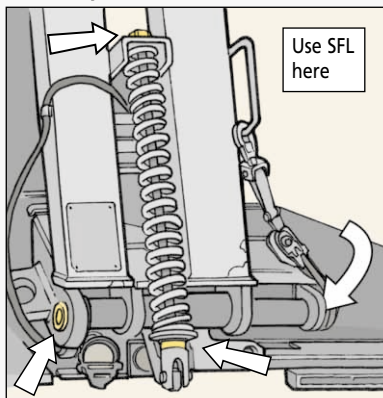
Solid film lubricant (SFL), not grease, is the required lube for the ramp pivot shafts and spring rod guides on M1000 HET semitrailer ramps.

SFL lubes the shafts and guides, without attracting dirt, grit and sand like grease. The grease-dirt-grit-sand combination works like sandpaper to score the surface of ramp pivot shafts and guides.

If your semitrailer's pins or guides now have grease on them, remove it with dry cleaning solvent. Then use SFL, NSN 9150-00-754-0064.
